Motorola DTR600/700/720 series two-way radio

Firmware Update info

6-July-2020

DTR600/700/720 two-way radios firmware to be updated to:

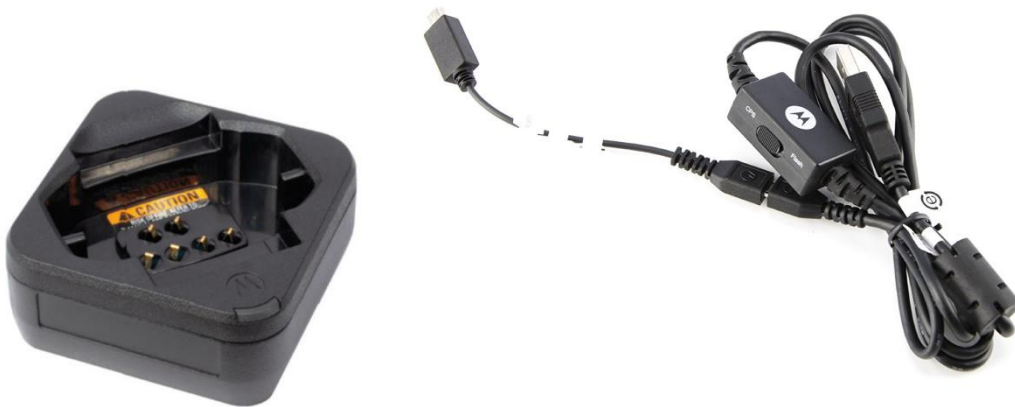
1. Prepare the below equipment.
 - a. CPS Cable kit is HKKN4027A.
 - b. Single Unit Charger/docking station PMPN4468A.

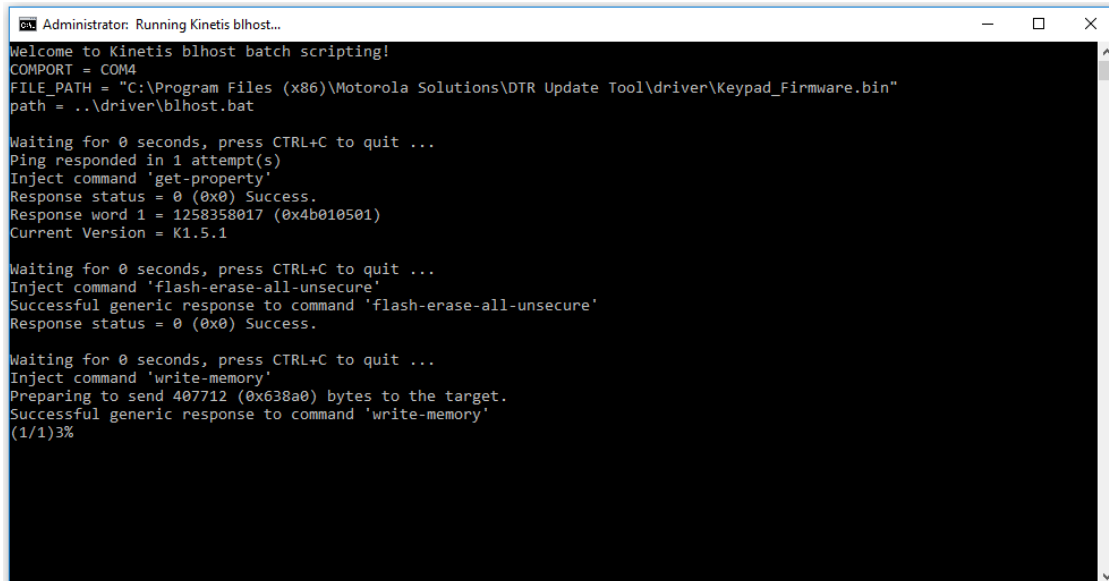
11. There will be a black pop up screen showing % of progress. Please do not press any button on your keyboard as that will pause the upgrading process. Please wait for the radio to be completely updated. This should take about 15 minutes.
Do not worry about what is shown on the radio display at this moment.
